PROPERTY INSPECTION REPORT FORM

Name of Client: ♡○○◆□♡♣⊗ ☾□★♠♠ @ **Report ID 030625PIRT** **Date of Inspection:** 03/06/2025

Address of Inspected Property: 0101 ☾☐☒◆☐☐♠♠☒☒☒☒◆★ ☾○★☐☐♡, Fort Worth, Texas 7600-0000

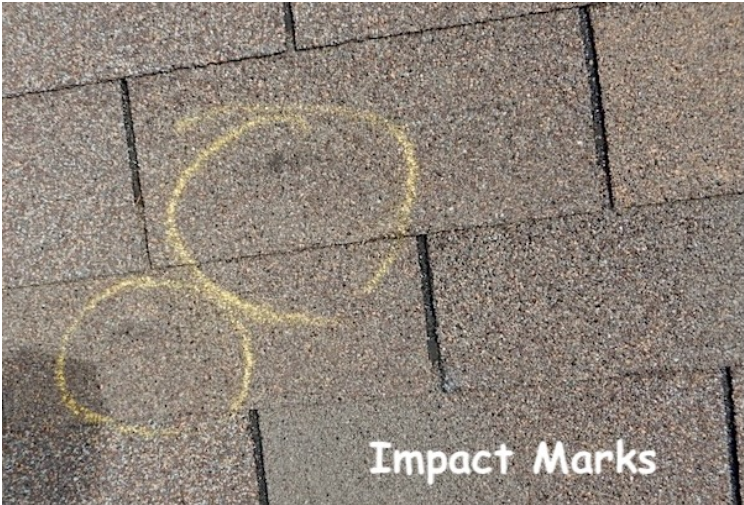
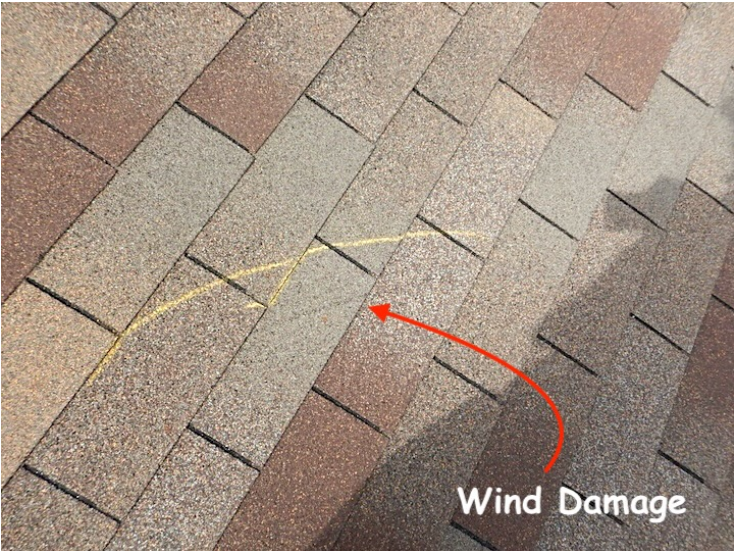
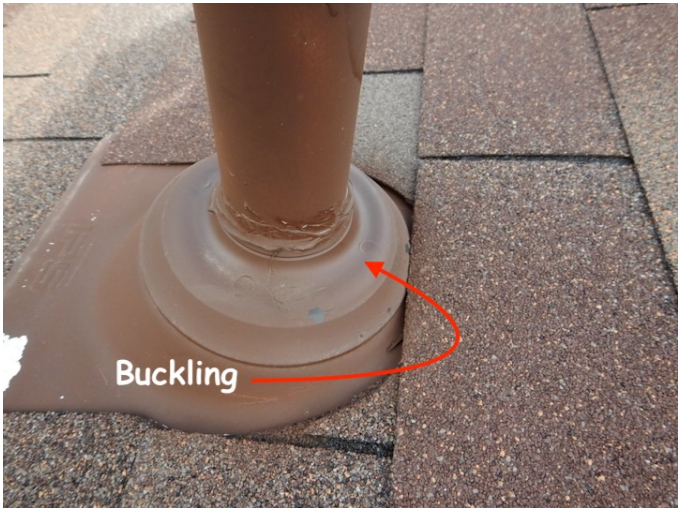
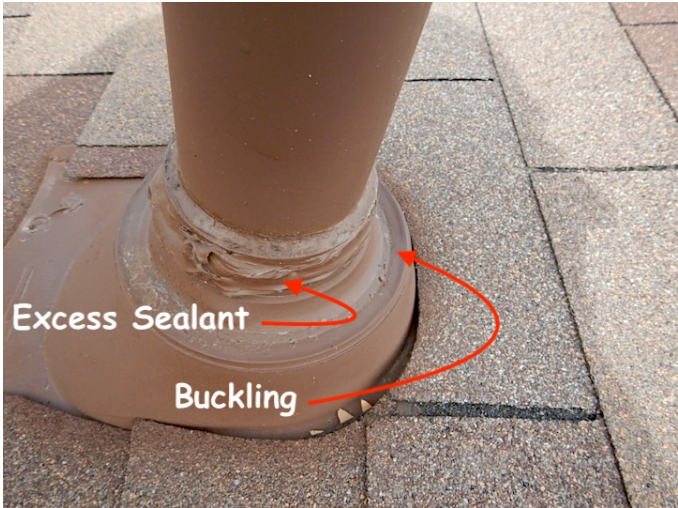
15. Starter courses had not been installed along the drip edges.
16. The first course shingles had not been sealed to the drip edge flashing.
17. There were no fewer than six impact damaged shingles on the main house roof covering ([Hail Damage Illustration.JPG](#)). Some of the suspect areas were marked with a yellow crayon to help a reputable roofing contractor more easily qualify these concerns.

18. There were no fewer than two wind damaged shingles on the main house roof covering.
19. There was some advance ceramic granule loss on the detached garage roof covering.

20. One of the plumbing vent-stack flashing gaskets were amateurishly/unconventionally repaired with a sealant. This is a temporary patch; the sealant will dry, shrink and crack. A proper repair would have been to install an auxiliary pipe boot system (e.g. www.perma-boot.com).

21. Some of the plumbing vent-pipe flashing jacket neoprene storm collars were inverted or buckled so that water can collect or pool around the pipe(s), compromising the seal and allowing water infiltration into the structure ([illustration](#)).

22. Several roof shingle issues apparent (see table below). Further evaluation by a specialist is recommended.

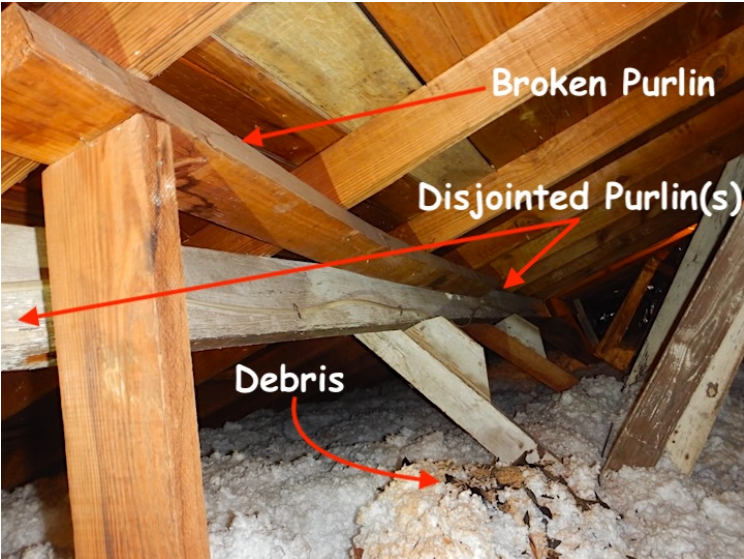
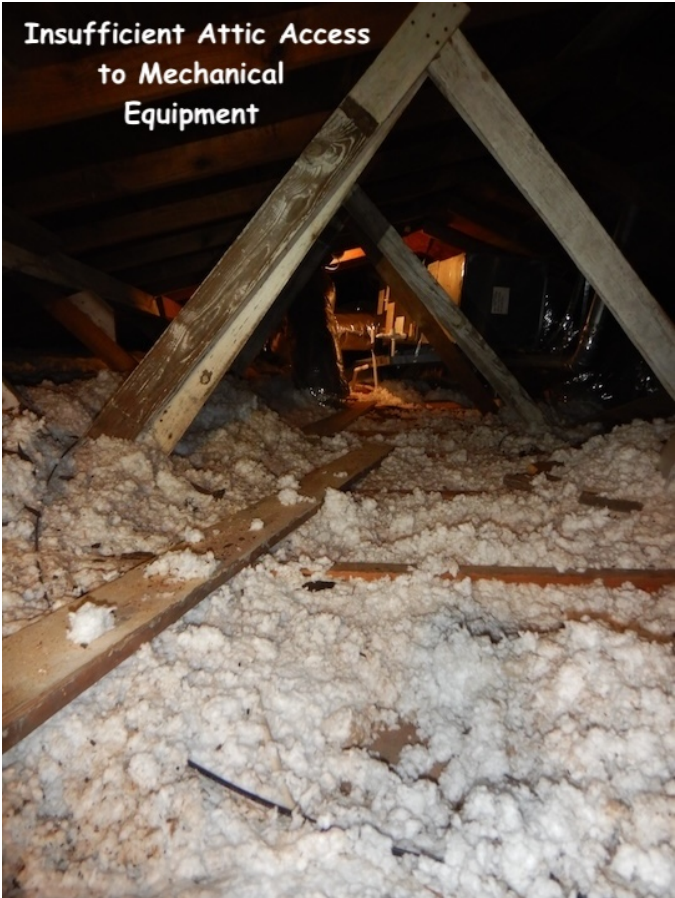
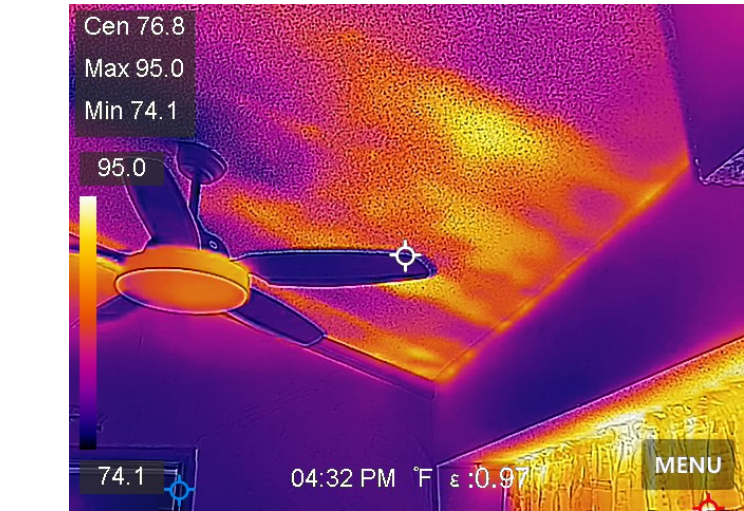
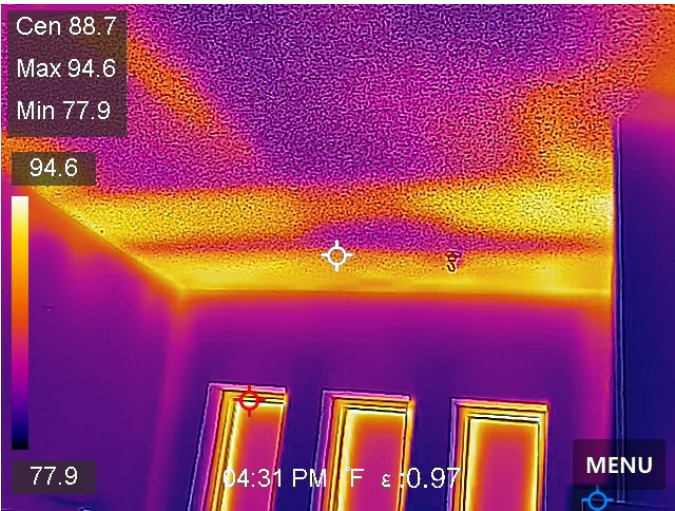
32. There were some disjointed purlins in the attic.
33. There was some debris in the attic insulation.
34. Some rodent feces and/or trails were observed in the attic space insulation.

35. cursory infrared imaging suggested that the attic insulation may have been lacking in several attic areas (e.g. formal dining area, primary suite bathroom, game room, sun room, northeast bedroom, etc.). Infrared imaging is the measurement and recording of heat and/or heat differentials at the time of inspection. Infrared imaging cannot determine whether an issue was, was not, or might again be present, only that an area may not have shown itself adequately at the time of the inspection. These items and/or issues are beyond the scope of this report, however, they were apparent and so noted. These observations were provided as a courtesy, are incomplete, and are partial in context. If additional infrared information and recording about this property is desired then a Certified Level I or II Thermographer should be contracted.

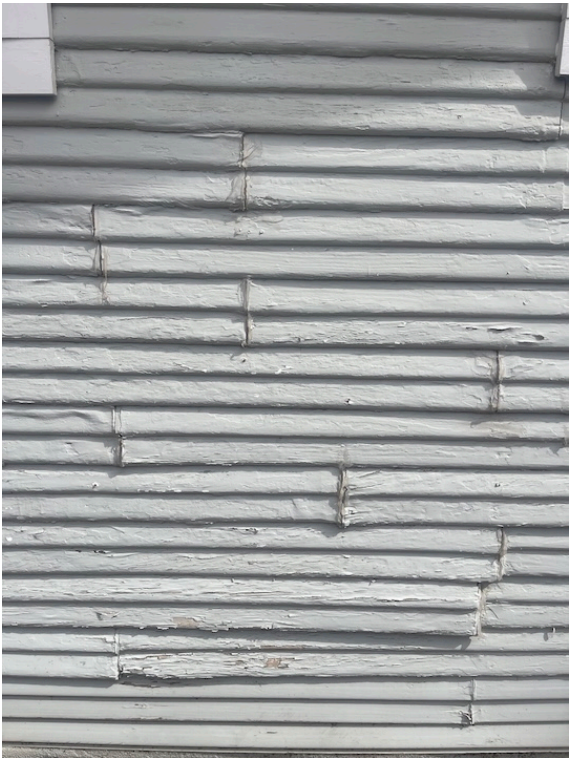
- 39. There was much cracking or peeling paint on the exterior wall system.
- 40. Some of the exterior siding and/or fascia was in direct contact with the roof covering material (e.g. gable ends).

- 41. Some of the garage exterior wall sole plate anchor bolts did not appear to have been properly positioned ([illustration](#)) and ([illustration](#)).

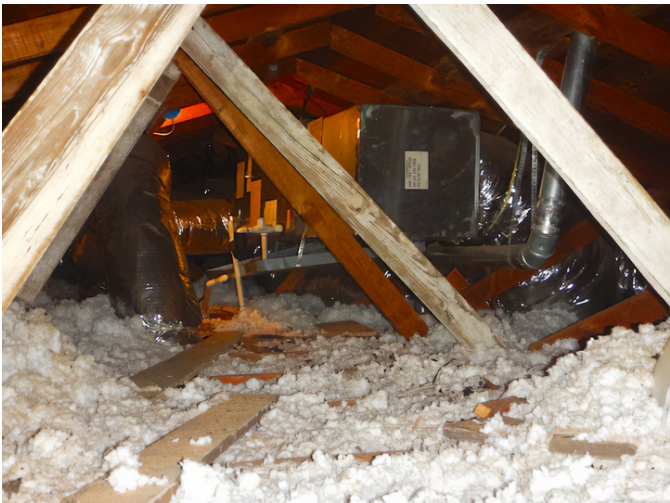
- 91. A use and care manual was not apparent at the indoor air handler.
- 92. Indoor air handler was not readily accessible, and observations are limited. An unobstructed 22” wide walkway was not present to the indoor air handler. A 30” unobstructed service platform was not present in front of indoor air handler. The attic access was less than 22 X 30 X 30”.

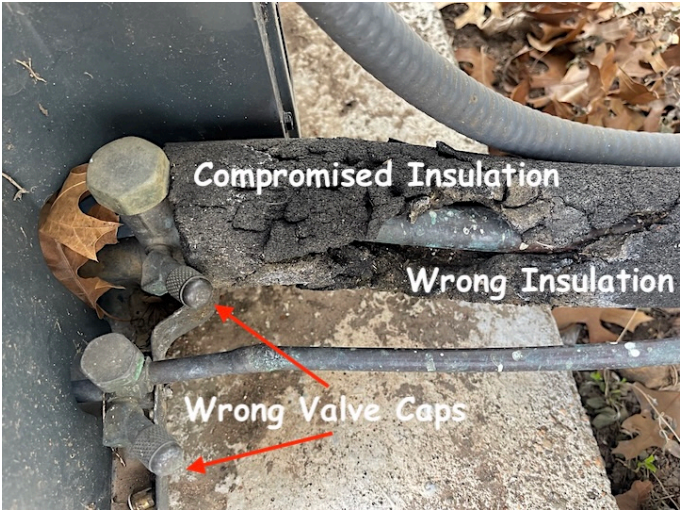
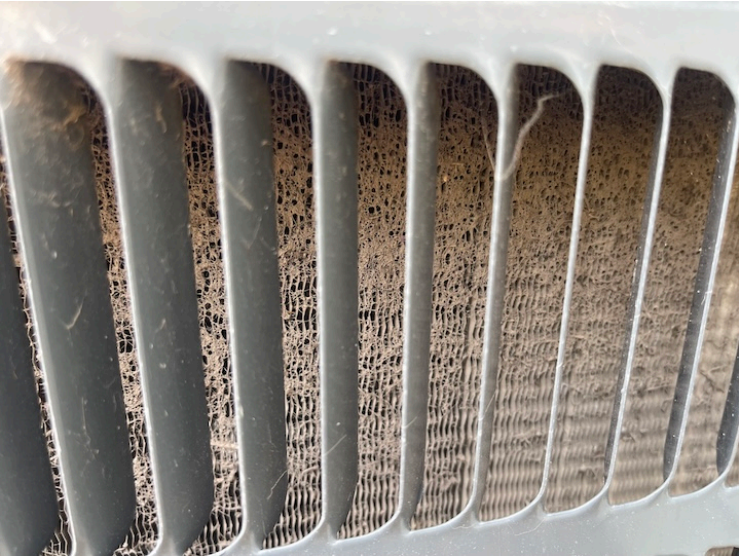
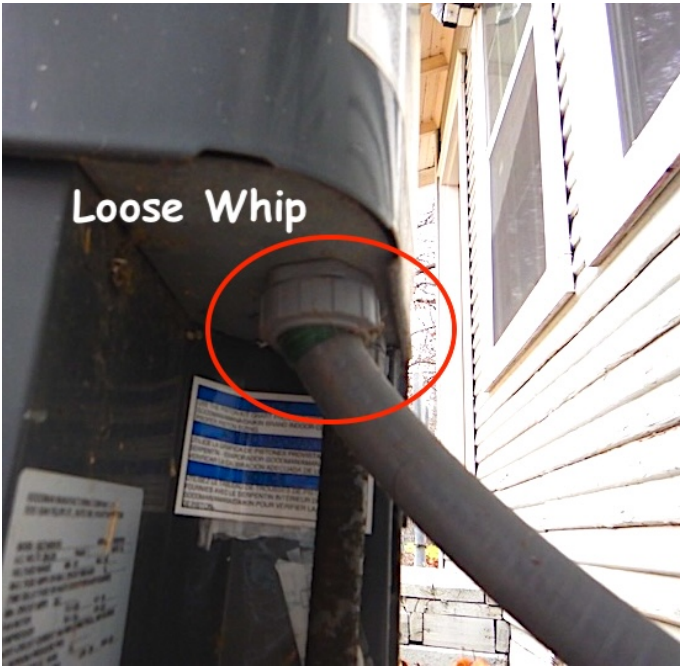
96. The electric power supply conduit whip to the condenser was loose where it was supposed to have been secure to the cabinet.
97. A rain gutter or some other type of water diverter was not installed over the condensing unit.
98. The condensing coils were dirty.
99. Some of the insulation was missing from the low pressure suction line near the condensing unit.
100. A protective cover is required on exposed refrigerant low pressure piping insulation near the condensing unit, as per the 2015 IECC ([Line Protection image](#)).
101. Anti-theft schrader valve caps were not installed on the refrigerant service ports (IMC. 1101.10). *These devices may not have been required when the current equipment was installed.*

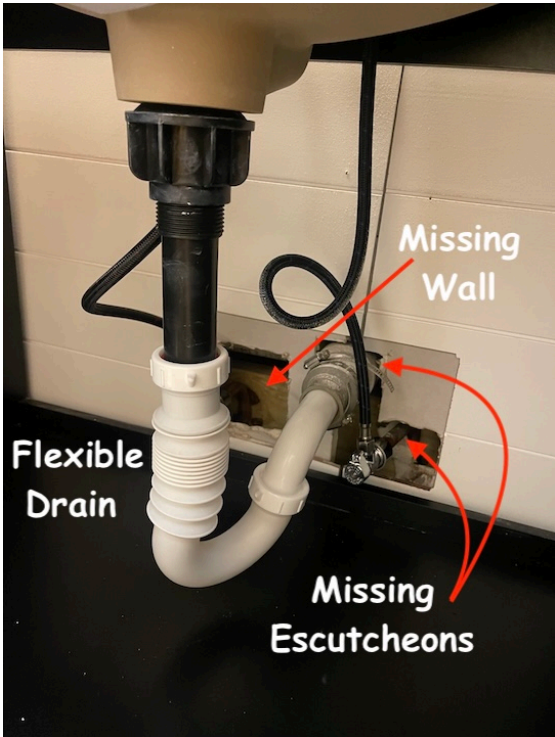
- 116. The horizontal PVC drain pipes in the crawl-space were improperly supported with perforated plumbers tape. This tape does not provide sufficient support to help prevent upthrust of the pipes ([illustration](#)).
- 117. Some flexible drain connections were observed (e.g. bathroom right/west lavatory basin drain). The IRC requires traps to be self cleaning, which flexible accordion type traps are not. Smooth interior surfaces should be on all waste pipe fittings to allow the free flow of drain water. Although the accordion-type, flexible fittings available at hardware stores may facilitate making connections, they will also reduce the rapid flow of water down the drain and may hold bacteria (an example of this issue from another property @ <https://youtu.be/LIH9xyPuXTE>).
- 118. Escutcheon wall plates were missing from all of the water drain piping wall penetrations.

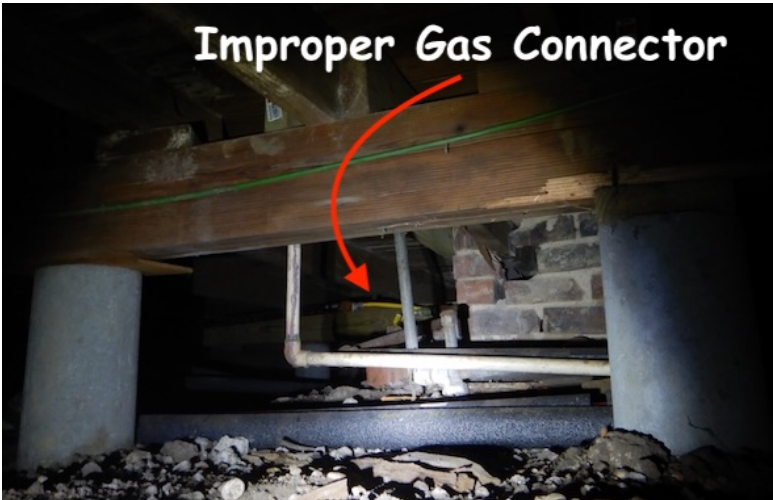
- 130. The gas piping in the crawl-crawl-space was not properly supported. The gas piping should have been secured to each floor joist it crossed perpendicularly.
- 131. A connector had been improperly used in the crawl-space instead of plumbing pipe directly to the range supply.
- 132. Gas valves are currently required to be located out from behind range appliances.
